NOTICE OF REGULAR MEETING OF THE GUADALUPE TOWN COUNCIL

TUESDAY, NOVEMBER 24, 2020

2. **COMMUNITY BLOCK GRANT PROGRAM (RESOLUTION NO. R2020.34):** Council will consider and may take action to approve Resolution No. 2020.34 authorizing the Town to submit an application to the Maricopa County Housing and Community Development Divisions for funding under the U.S. Department of Housing and Urban Development's (HUD) Community Development Block Grant (CDBG) program to be utilized for a wastewater system rehabilitation project consisting of the repair and replacement of nine sewer line segments totaling 3,297 linear feet of pipe and nine manhole structures with engineering

The operation and maintenance of a Wastewater Collection System (WCS) is crucial to the health and safety of the general public. Therefore, the Town of Guadalupe (Town) contracted with Dibble Engineering (Dibble) to conduct a condition assessment of their WCS. The majority of the Town's WCS was constructed in 1978 and this condition assessment is the first to be completed on the system.

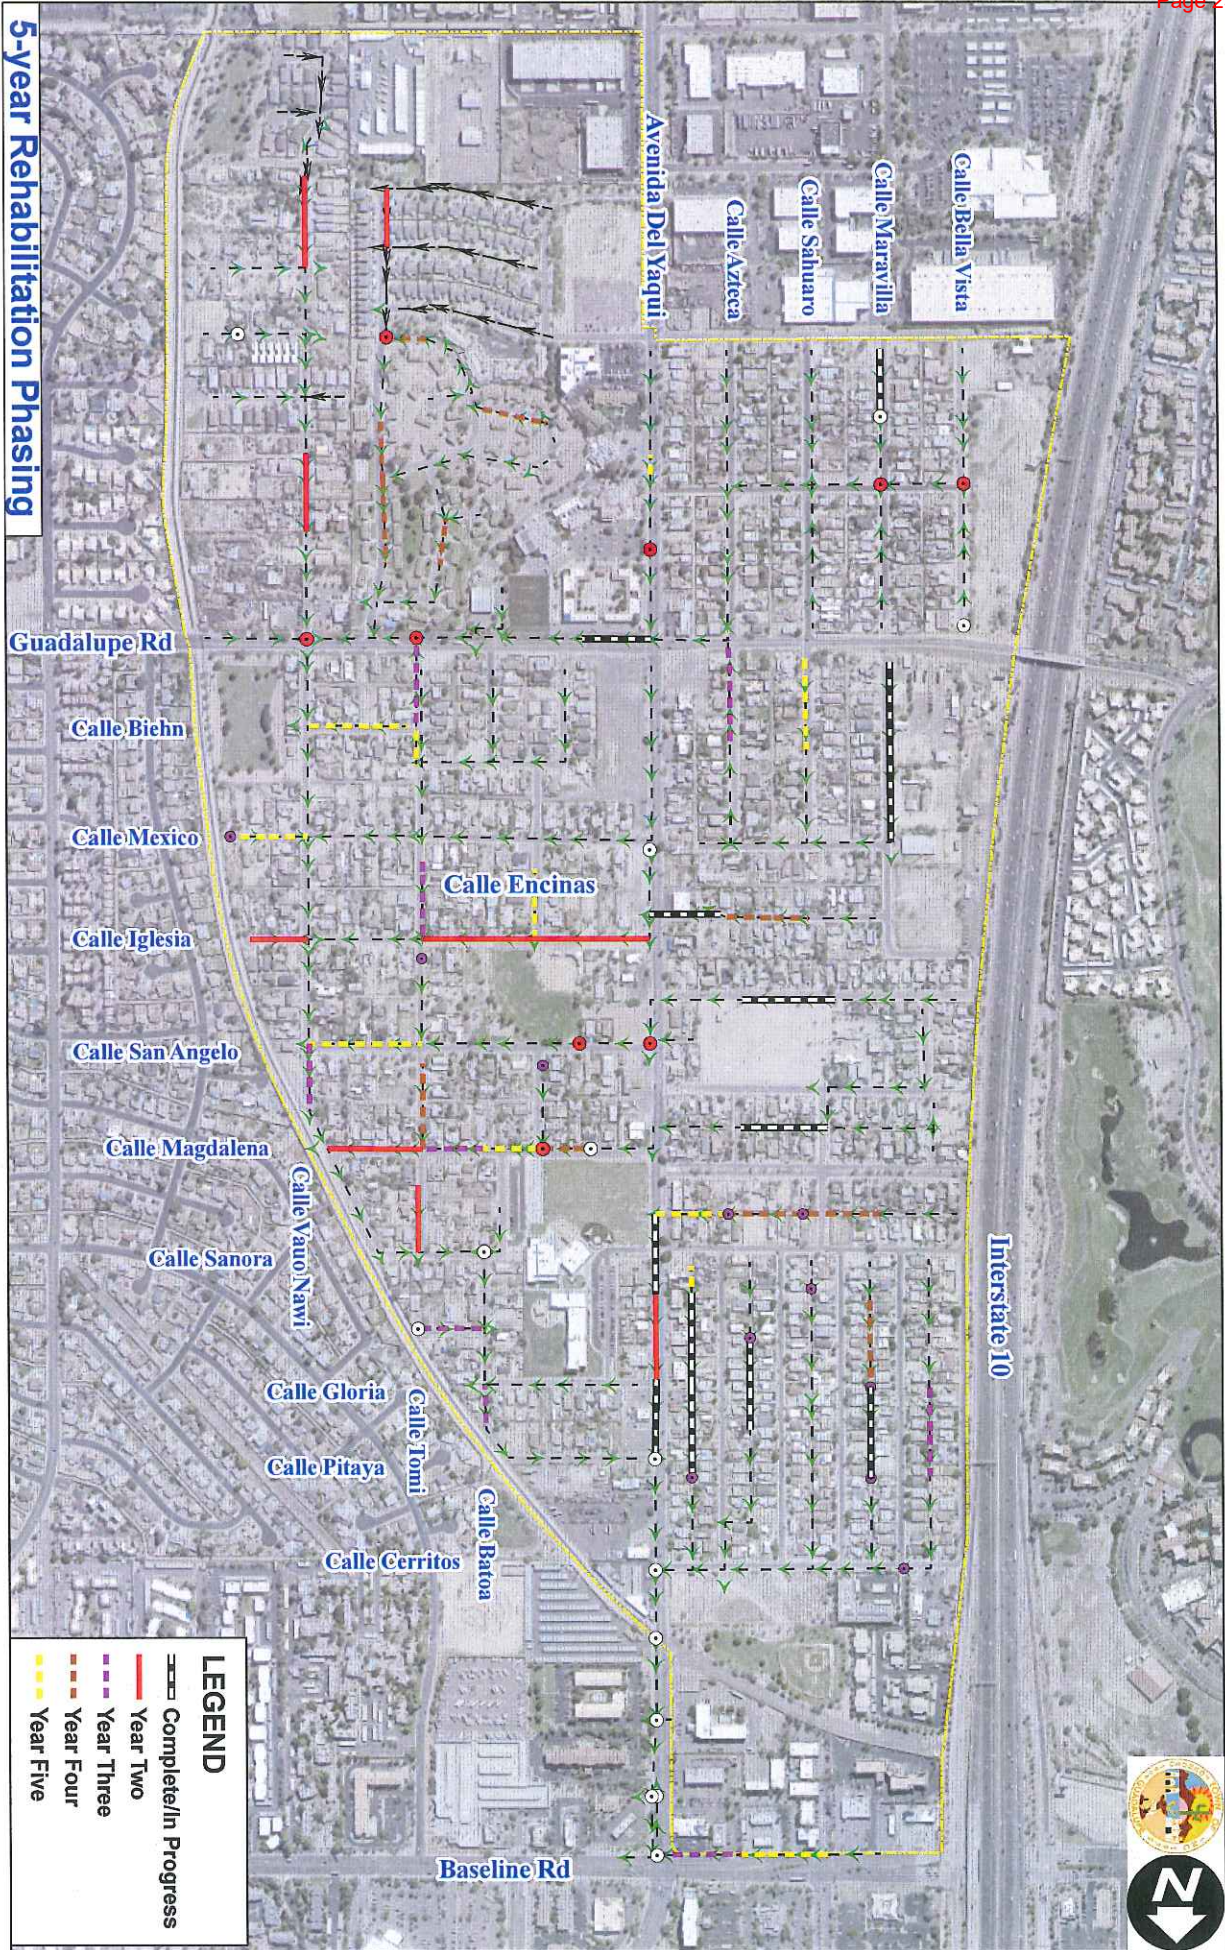
5-year Rehabilitation Phasing

- Complete/In Progress
- Year Two
- Year Three
- Year Four
- Year Five

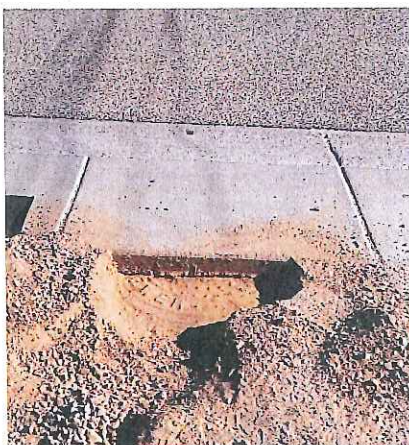
Figure 1 – Calle Batoua Buried Manhole

As mentioned, the total number of manholes assessed during this project is 192. 7 manholes could not be located due to being buried under concrete sidewalk or asphalt roadway. The locations of these inaccessible manholes were reported to the Town as requiring additional work to raise these manholes to grade, refer to *Figure 1*.

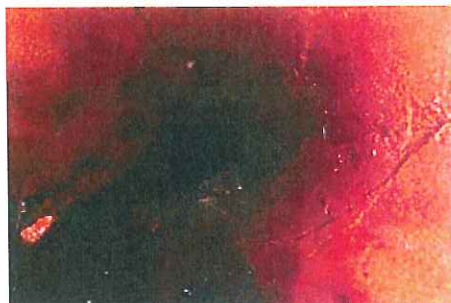
Figure 2 - Collapse Pipe (XP) Defect

As noted above, grade 5 defects observed within the Town's WCS included Collapse Pipe (XP), Broken Soil Visible (BSV) and Hole Soil Visible (HSV), refer to *Figure 2*, *Figure 3*, and *Figure 4*.

The condition assessment identified 10 pipe segments with grade 5 defects and 24 pipe segments with grade 4 defects.

At the completion of the manhole locating process, pipe segment lists were generated to complete cleaning and CCTV of each pipe segment. Once CCTV was completed the resulting video was reviewed by National Association of Sanitary Sewer Companies (NASSCO) certified technicians to identify defects within each pipe segment. Observed defects are separated into two categories, Structural, and Operation & Maintenance (O&M). Each defect observed is assigned a number grade from 5 (severe) to 1 (excellent). 11 grade 5 structural defects and 31 O&M grade 5 defects were observed within the WCS. 2 pipe segments were observed to have multiple fractures resulting in partially collapsed pipe. These segments are recommended for immediate repair.

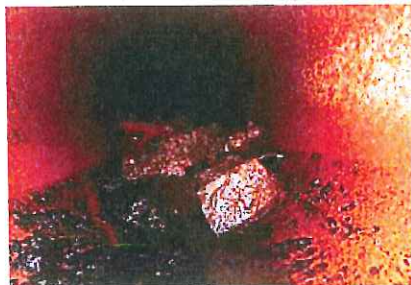
Figure 5 - Deposits ingress Settled (DNZ) Defect

Figure 5 through 8 show typical grade 5 O&M defects observed within the Town's WCS.

These grade 5 defects typically require heavy cleaning by mechanical measures using a carbide saw or chain flail knocker and multiple passes with the hydro-blast jetter.

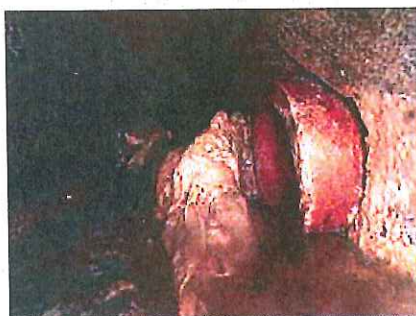
Figure 9 - Tap Break-in Intruding (TBI) Defect

There were several intruding service taps observed within the Town's WCS. The grade 5 TBI defect listed in the table above is protruding into the sewer main to block greater than 30-percent of the pipe cross sectional area which may cause backup due to debris being unable to pass the tap, refer to *Figure 9*.

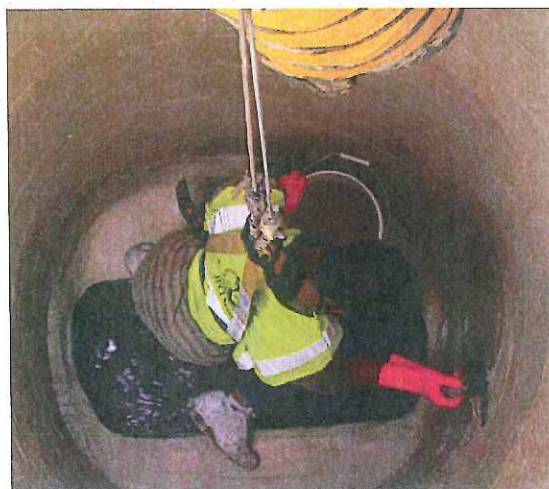
Figure 10 – Trowel Epoxy Coating Application

One method of rehabilitation for concrete manholes is to prepare the interior of the manhole exposing sound, solid substrate and then installing a coating onto the interior surfaces of the manhole with either epoxy or polyurethane materials. Epoxy and polyurethane coatings consist of two components, a resin and a hardener, which are mixed just prior to application. Applications of epoxy coatings can be sprayed or troweled onto the concrete surface, refer to *Figure 10*. Polyurethane coatings typically use a spray application.

To avoid expensive bypass pumping costs, typically the coatings are applied during low flow conditions and the use of flow through plugs to eliminate water in the manhole invert. The coating is applied on all exposed surfaces.

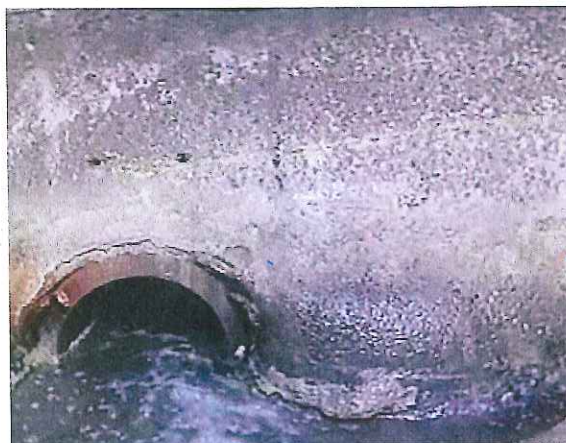
Figure 11 - Early Concrete Deterioration

Concrete manholes are extremely susceptible to corrosion in H₂S gas environments. Over time H₂S gas oxidizes and reacts with the silica cement. As the deleterious reaction continues, concrete spalls thus compromising structural integrity of the manhole. In high concentration H₂S environments concrete deterioration can occur more quickly and thus rehabilitation may be required sooner without proper interior wall protection.

Epoxy and polyurethane coatings are recommended solutions for concrete access manholes with early stages of concrete deterioration as observed within the Town's WCS. Indication of early stages are; increased surface roughness, concrete aggregate is visible, and surface spalling, refer to *Figure 11*.

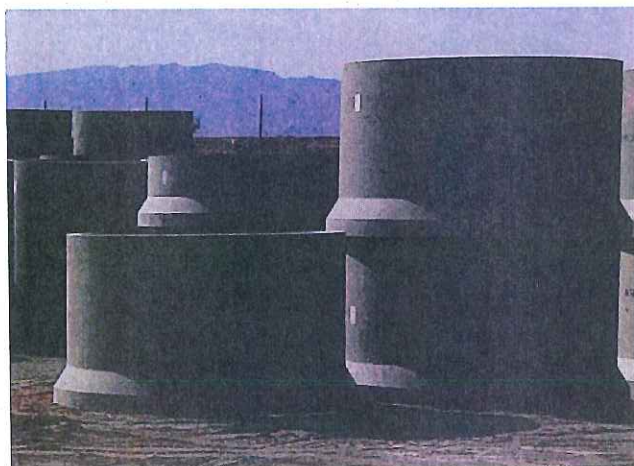
Figure 12 - Polymer Concrete Manhole Insert

Rehabilitation for manholes with compromised structural performance can be accomplished using internal manhole structural inserts. The manhole structural insert is typically pre-fabricated, delivered to the site and inserted into the manhole interior. The structural inserts are typically constructed using fiberglass or polymer concrete, refer to *Figure 12* & *Figure 13*.

The method of installation for pre-fabricated manhole inserts is described as follows: The cone of the existing manhole is removed, and the interior is then pressure-washed to removed loose material that may interfere with the insert installation. A leveling course of corrosive resistant grout is placed on the manhole bench to eliminate projections that could cause point loading on the insert. The leveling course of grout also seals the bottom of the insert to prevent annular space grout from leaking into the manhole channel during installation. Inserts can be fabricated as either one single unit, or in sections depending on the manufacturer or installation location constraints. Grout is then poured into the annular space between the new insert and existing manhole. The manhole is then backfilled, and frame and cover surface repairs are made to restore to original conditions.

To prevent water infiltration, a manufacturer approved sealant material is used at all joints and pipe connections. Since the pre-fabricated insert is designed to fit inside the existing manhole, the interior diameter of the new manhole will be reduced by approximately 6-inches.

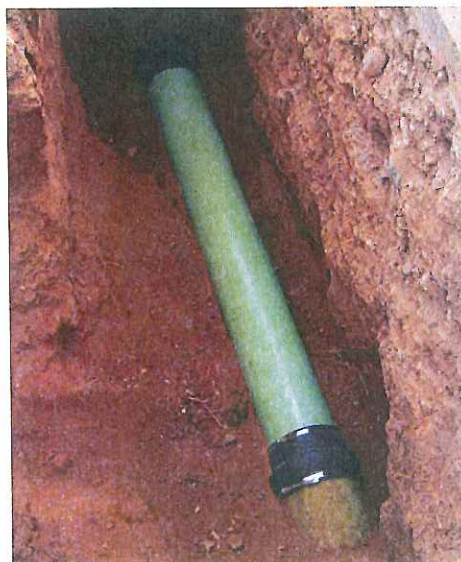
Figure 14 - Point Repair

Point repair is the open cut excavation method used to replace severely damaged or collapsed pipe, refer to *Figure 14*. Point repair is required where the pipe conditions are not conducive to CIPP lining. Point repair is the recommended method of rehabilitation and most cost effective where the defect is limited to approximately a 10-foot section, the pipe depth is less than 5-feet below the surface, and the location of the pipe is in a low traffic or landscaped area. To complete the point repair sewage must be diverted around the construction area.

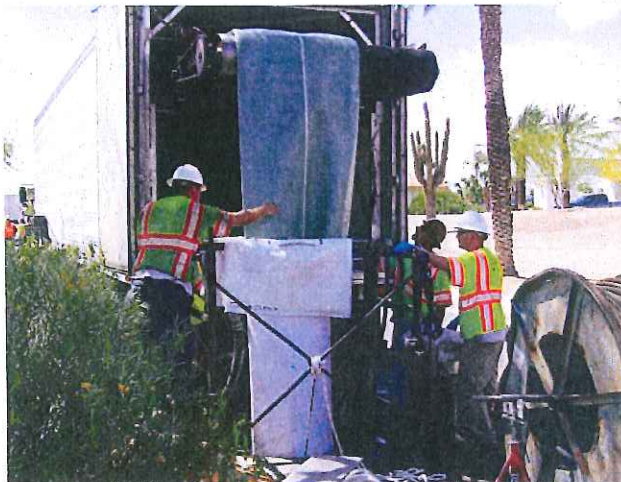
Figure 15 – Inversion CIPP Liner Insertion

CIPP rehabilitation is a trenchless construction method that is used to repair existing sewer pipe 4-inches and larger, refer to *Figure 15 & Figure 16*. In the CIPP rehabilitation process, a resin-impregnated flexible felt, or fiberglass tube liner is inserted into the pipe through an existing access manhole using water, air pressure, or winched in using a cable. The resin is then cured inside the existing pipe using hot water, steam, or Ultraviolet (UV) light to form a tight-fitting, jointless, corrosion-resistant lining on the interior of the existing pipe. Service laterals are reinstated using remote controlled cutting devices. Lateral seal connections can be installed where the connection is damaged or is not water tight. The lateral seal connection prevents corrosion to the exposed pipe wall from the initial lateral reinstatement.

The thickness of CIPP lining is designed for fully-deteriorated host pipe conditions, various soil parameters, the presence of ground water, pipe ovality, and applicable live loads. Even though the pipe diameter is decreased, anticipated pipe flow capacity is typically increased due to a decreased coefficient of friction (smoother pipe wall) of the CIPP lined pipe.

A bypass pumping operation, cleaning, and removal of protruding objects, obstructions, and debris is usually necessary prior to CIPP rehabilitation. Bypass operations may not be required when pipe diameter is less than 12-inches depending on the storage capacity of the collection system upstream of the work area. Small diameter pipe flow can typically be handled with sewer system capacity at low flow conditions, for typically 2 to 4 hours while the liner is installed and cured.

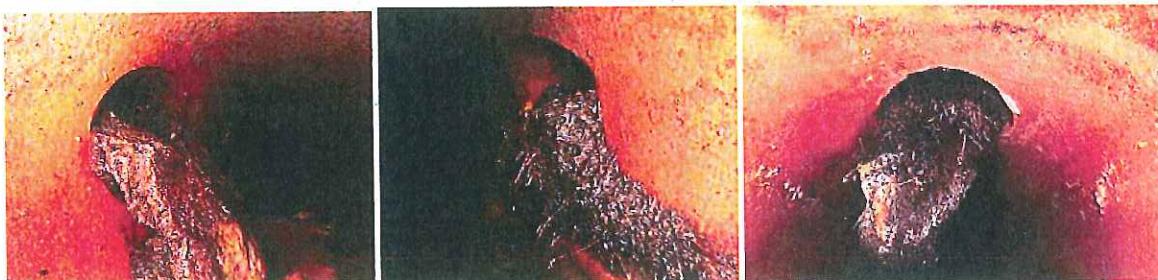
Figure 17 - Lateral Root Intrusion

The condition assessment process identified 24 O&M root intrusion defects extending from service laterals into the mainline pipe, refer to *Figure 17*. Roots observed entering the mainline from service laterals could create issues for the owners of the home or business the lateral is servicing. It is recommended that the owners with roots observed in their laterals be notified in order to give them the opportunity of having them removed prior to the root creating a back-up problem. Town ordinances clarify that the service lateral extending from the home/business to the main line is the responsibility of the owner.
